Manhole Inspection Summary

Manhole # S35A__015MH

Insp Date: **8/21/08 10:17 AM**

Location Address: **side 210 n guilford ave**

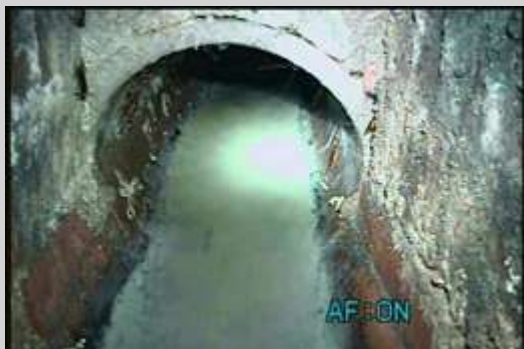
6 O'Clock Inflow

10 in. Circular Gravity Sewer
Pipe In @ 6 O'Clock

Pipe Height: 0 (in.) Direct

Pipe Material: **Clay** ☐ Pipe Lined

Infiltration: **None** Pipe Seal Cond: **Unknown**
